TECHNICAL BULLETIN – TB251

CONSIDERATIONS AROUND WATERPROOFING AND TILING OVER EXISTING TILED SURFACES - EXTERNALLY

Date, Tuesday, 27 June 2017

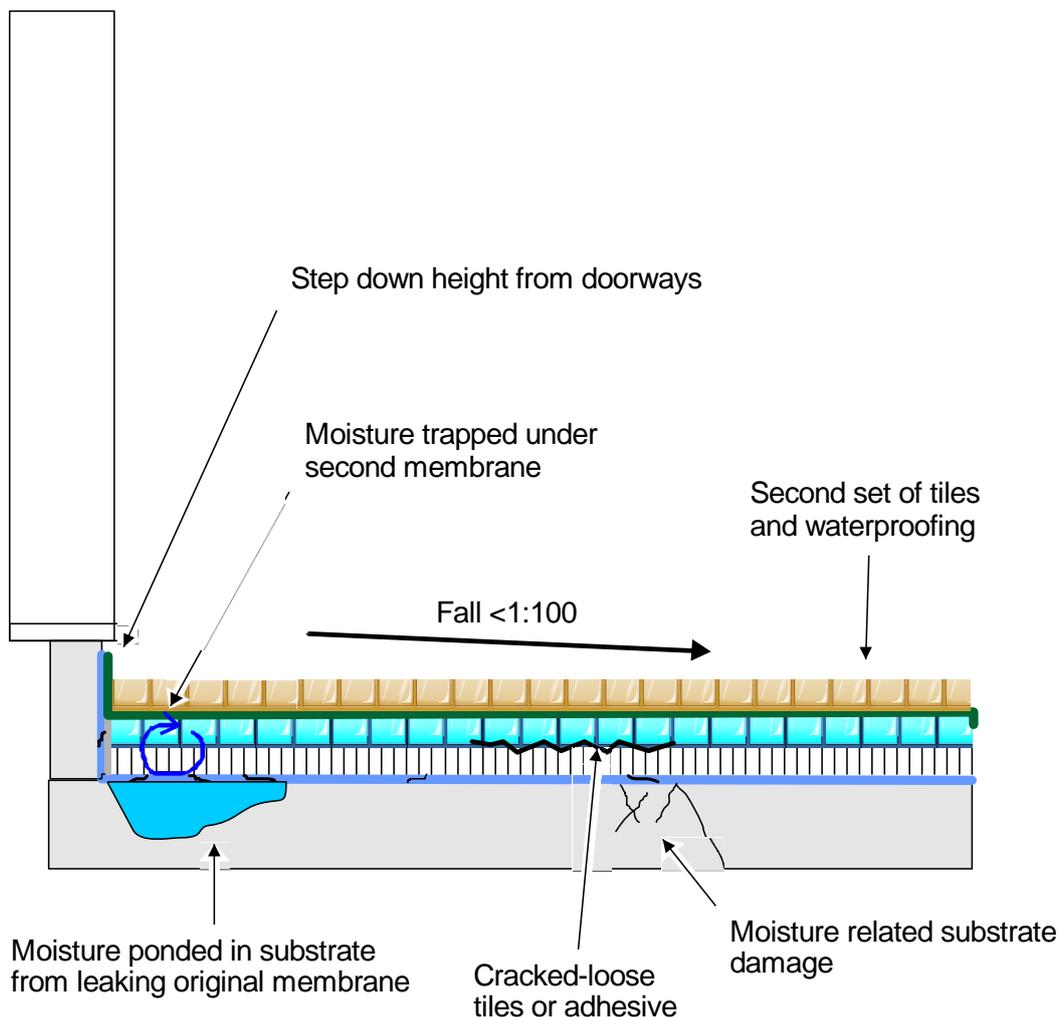
This diagram shows some of the problems that can be expected from this sort of installation.

As a consequence ARDEX is not in favour of this process and recommends a complete reinstallation. As a result we are not offering a standardised system, and it falls back to the persons investigating or doing the rectification to examine all the issues and then see if a viable system can be worked.
