TECHNICAL BULLETIN – TB130

SOURCES OF GROUT DISCOLOURATION

REAL AND PERCEIVED

Date, Tuesday, 30 January 2018

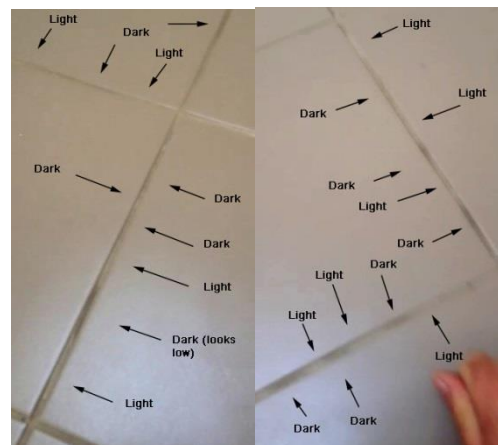
Figure 1.

An example of light-dark shading in grout lines due to apparent varying thickness of grout

What happens next is shown in the attached photo of a complaint, and the explanatory schematic diagram. As the grout dries at varying thicknesses in the grout lines, the chemical reactions for cement occur differently, in part because thinness vs thickness changes the way the water stays in the grout to react the cement, but also due to the differing properties of the adhesive vs any voids and exposed substrate. Where the grout is thinner it dries lighter, and where thicker dries darker. This pattern is then reflected in the grout and you end up with a set of zebra stripes in the grout lines. The intensity of this colouration pattern varies, but is pretty easy to spot with darker grouts.

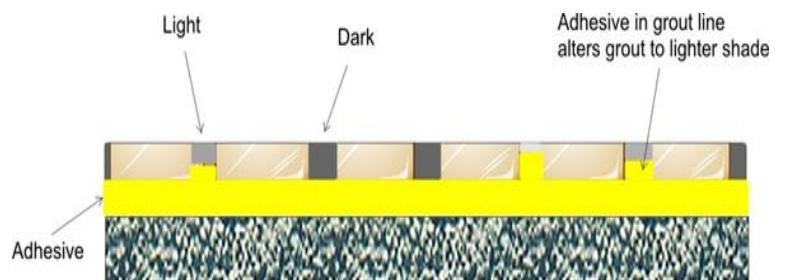
Figure 2.

Schematic diagram showing how the light dark shading effect occurs

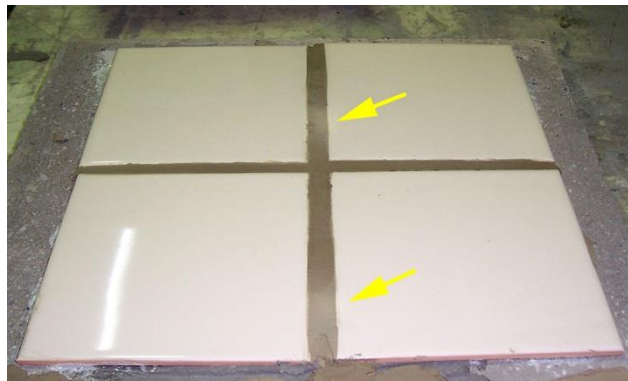
Figure 3.

An example of grout shading deliberately created in a laboratory trial, by not fully removing the adhesive from the notch lines. The areas of thin grout are arrowed. Note that the horizontal line of grout is correct colour. This test grout came from another site complaint

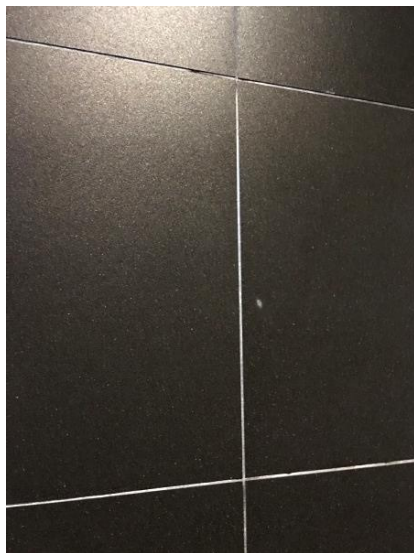
Figure 4a.

An example of over-watered black grout. Note the white bleached colour typical of grout where too much water is added.

Careful examination will also show track marks due to variable grout thickness, likely a result of failure to clean grout lines of excess adhesive.

Where the installer has added too much water, this can alter the colour due to both alterations in the cement properties and also separation of the colouring oxides from the mix. Also, the excess water takes longer to dissipate from the grout leading to apparent darkness, however the final resultant grout can be paler than expected, and also streaky or blotchy in appearance.

There is no simple remedy to this problem other than re-installation.

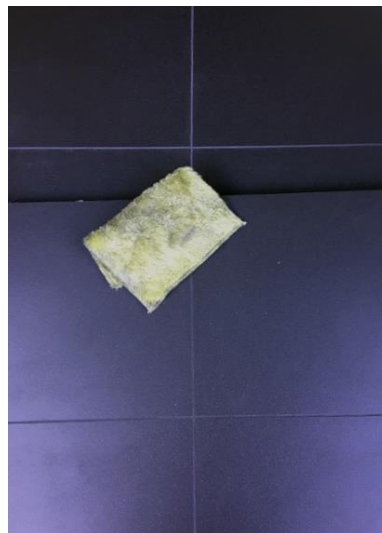
Figure 4b

An example of the same grout mixed with the correct amount of water, and cleaned using a fabric cloth with minimal wash water. Colour is correct and consistent. No tracking can be seen because grout is constant thickness because excess adhesive removed from grout lines.

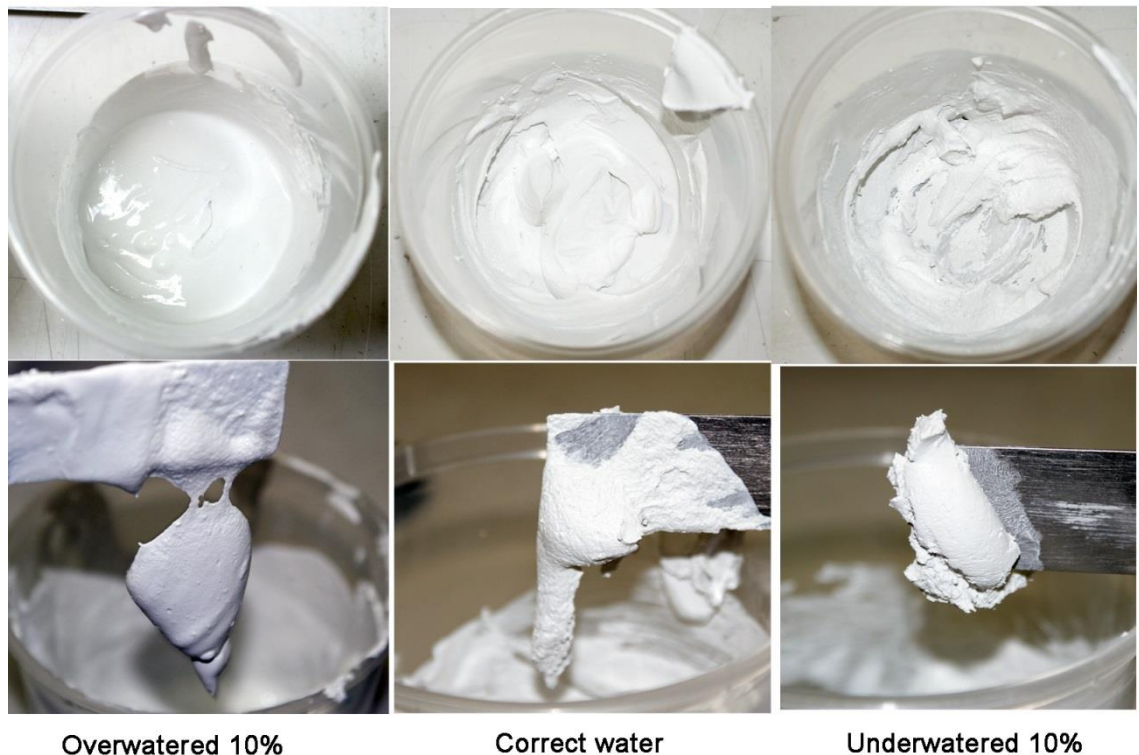
Figure 5. Examples of mixed fine grained grout.

The 'Goldie Locks effect': the one on the left is too thin and flows and runs, the one on the right is too thick and gritty, and the one in the middle is just right with some slump.

The grout is designed to be mixed with a certain ratio of water to form a soft paste of roughly creamy consistency that holds its shape like traditional toothpaste. Examples of mixed grout are shown in the next page.

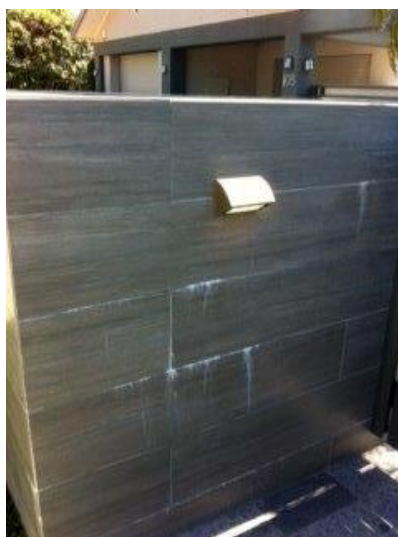
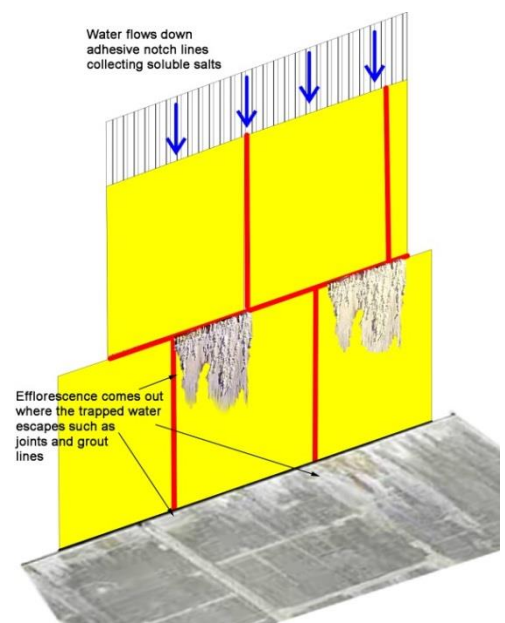
Figure 6a-b.

An example showing how secondary efflorescence can develop in a masonry wall due to movement of moisture under the tiles, and in contact with cementitious materials. This problem is not caused specifically by the grout.

Rain water running down tiled facades between the masonry walls and the tiled surface can generate significant efflorescence on the grout lines. Run off can also create efflorescence on the edges, but also within the field of decks and verandahs (Figs 6a-b and 7).

Figure 6a-b below shows some examples of secondary efflorescence where the grout is not the causative source.

- I. Stick to the correct water mixing ratios during installation.
- II. Check that the slab or screed is properly cured and dry. Slabs typically take 28 days to cure, though drying is typically 25mm per month (1mm per day) of slab thickness. Screeds take around 7 days to cure, and dry around 1mm per day.

- III. Check that rising damp is not present.
- IV. Try to work at temperatures above 10°C and have adequate ventilation to promote water evaporation.
- V. Allow adequate curing times for the tile adhesive.
- VI. Where rising damp occurs a subfloor membrane may be required.

- I. Where it is light, use of a **white** nylon bristle brush can loosen the powder enough to be vacuumed up.
- II. Where the efflorescence is slight to medium, scrubbing with a white bristle nylon brush and several water washes should progressively remove the deposits.
- III. A more aggressive method is to use white vinegar (commonly around ~5%-10% Acetic Acid) which will neutralise the deposits and dissolve them. Thorough water rinsing is required afterwards.
- IV. Use a commercial efflorescence/contaminant remover following the product instructions such as ARDEX ACP23 or ARDEX ACP25 .
- V. Medium to heavy efflorescence may require more vigorous methods of cleaning, and should not be done as a regular practice. This involves using a dilute solution of Hydrochloric Acid (<5%) and a stiff white nylon brush.

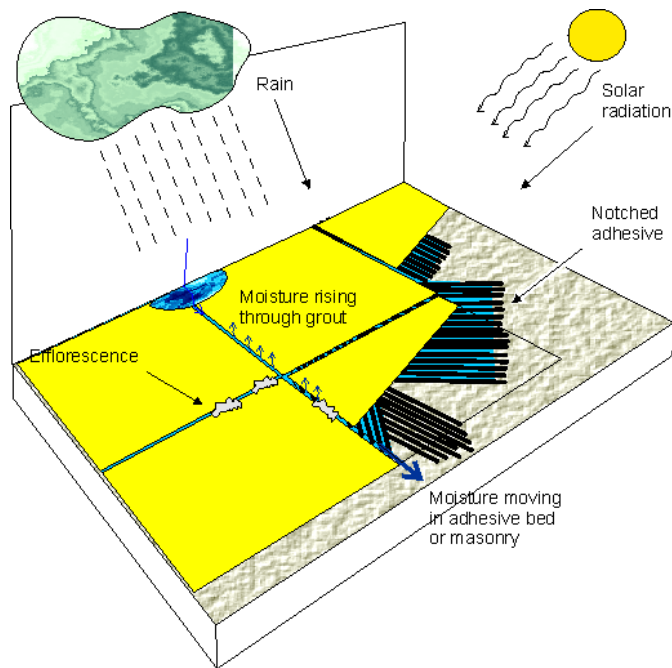
Figure 7. Another situation where water trapped in adhesive voids moves down the falls, or even ponds, and collects soluble materials. Solar heating of the tile surface drives the dissolution more aggressively and then encourages re-deposition of the salts rapidly where the water can escape.

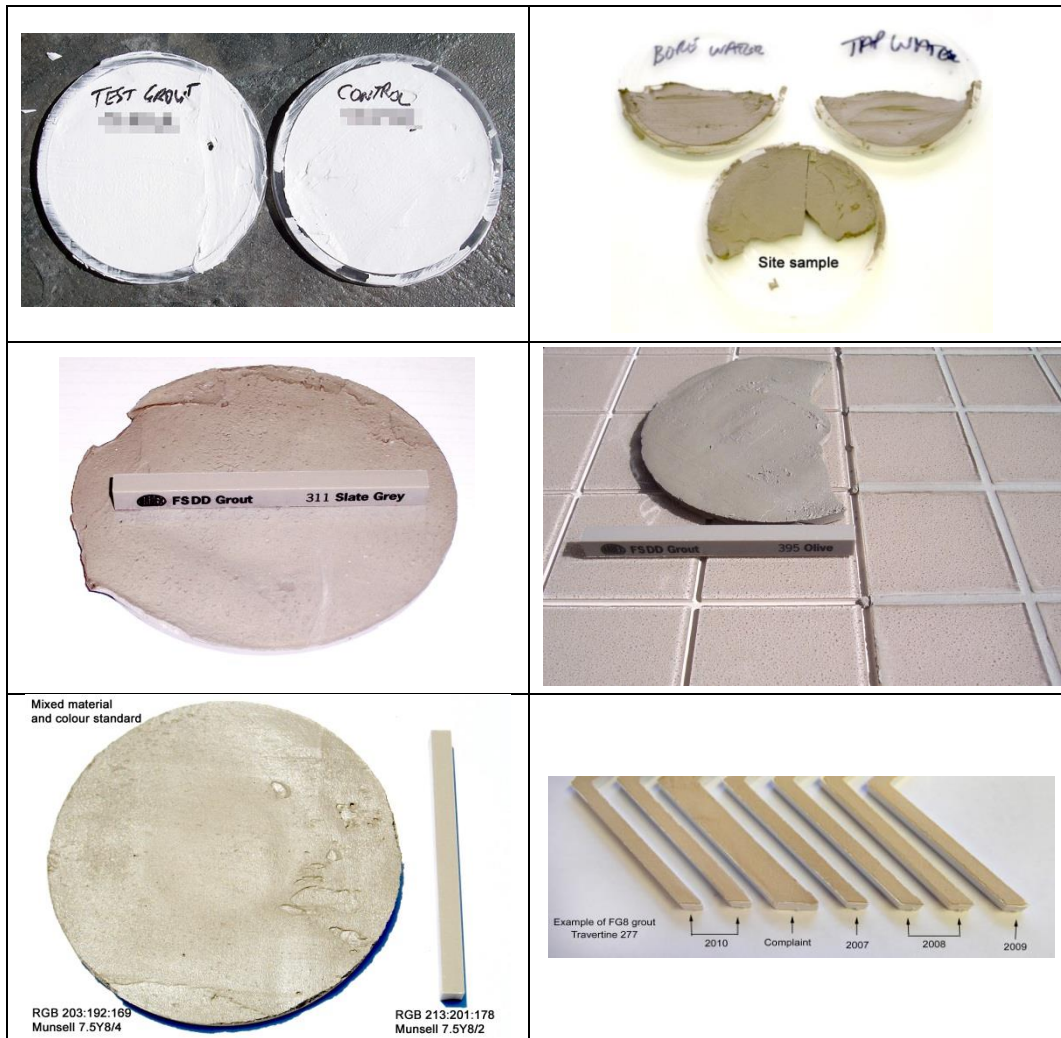
Figure 8.

Examples of grout from site complaints to check colour fidelity. As can be seen, the samples are consistent colour, including the sample mixed with bore water.

In one case, it can be seen the shade of the grout samples had not displayed any significant change in four years.

If the grout still is patchy or there is some other problem, then further investigation may well be needed and the material returned for examination. Examples of several such investigations of grout colour/patchiness complaints since 2009 are shown in Fig.8.
